NBSIR 79-1915

Investigation of the Effects of Heating and Air Conditioning on the Performance of Smoke Detectors in Mobile Homes

Richard W. Bukowski

**Center for Fire Research
National Engineering Laboratory
National Bureau of Standards
Washington, D.C. 20234**

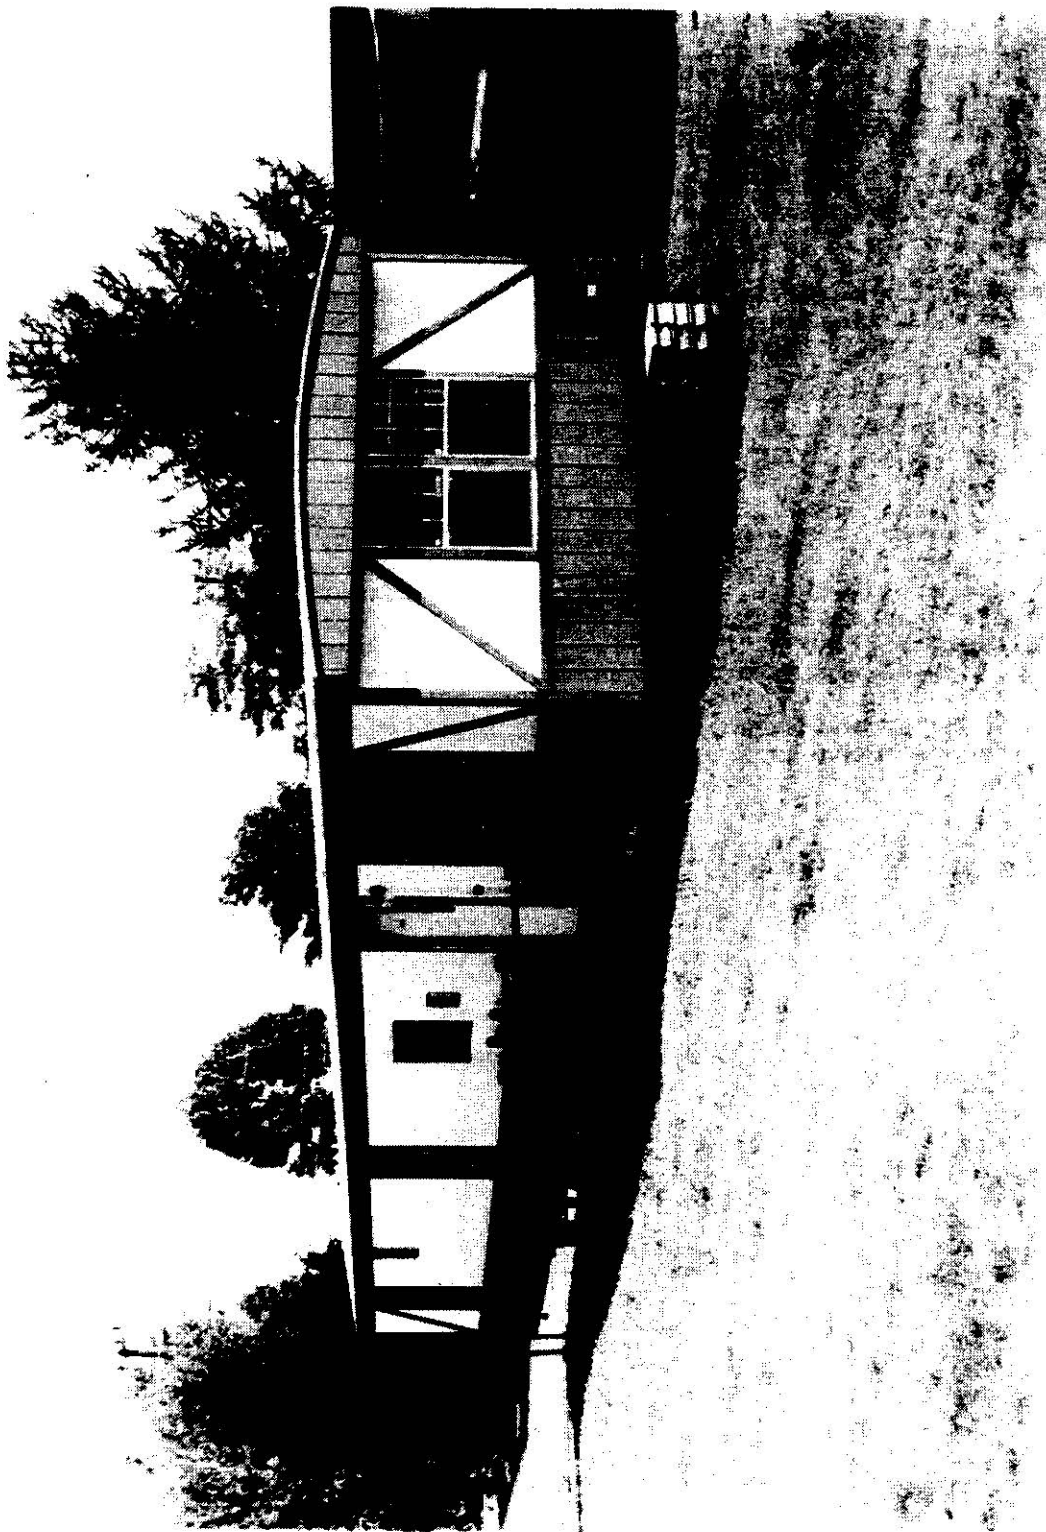
Figure 1. Mobile home test unit, north and west exposures (living room end)

The single-wide mobile home purchased for use in this test program was a 4.3 by 17 m (14 by 56 ft), two bedroom unit with front living room, central kitchen, and both bedrooms in the rear (see figures 1 thru 4). The mobile home was equipped with an oil-fired, hot-air furnace and an electric central air conditioning unit. It was constructed and certified in accordance the current edition of the FMHCSS, and included the standard exterior wall and ceiling insulation.

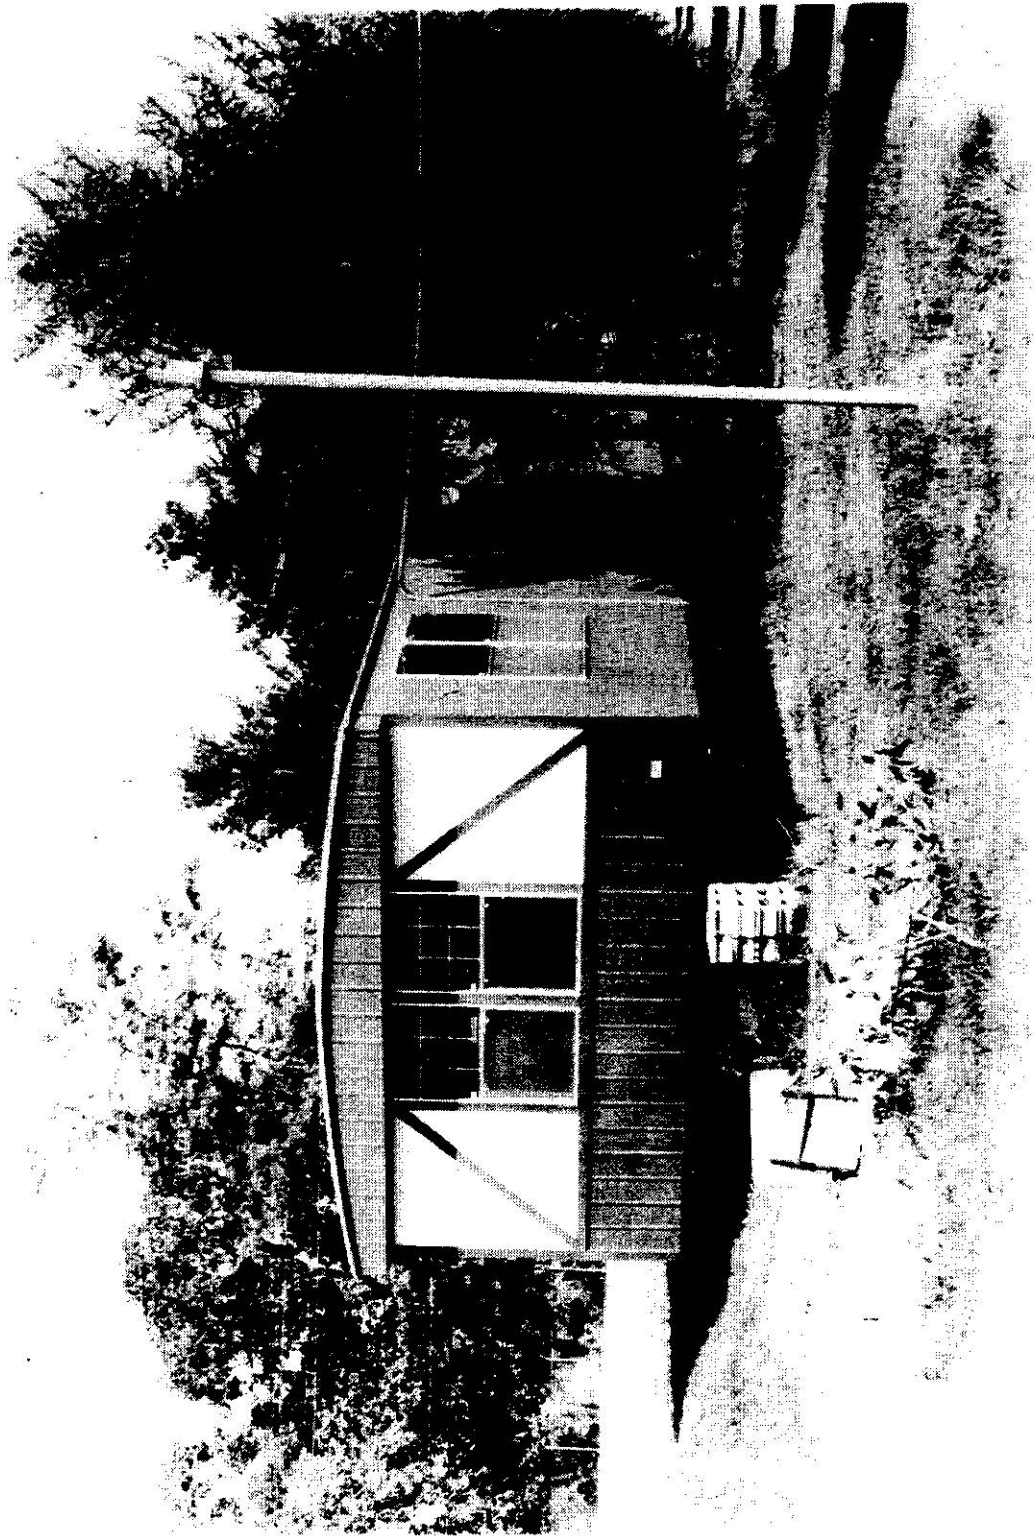
Figure 2. Mobile home test unit showing south wall of living room

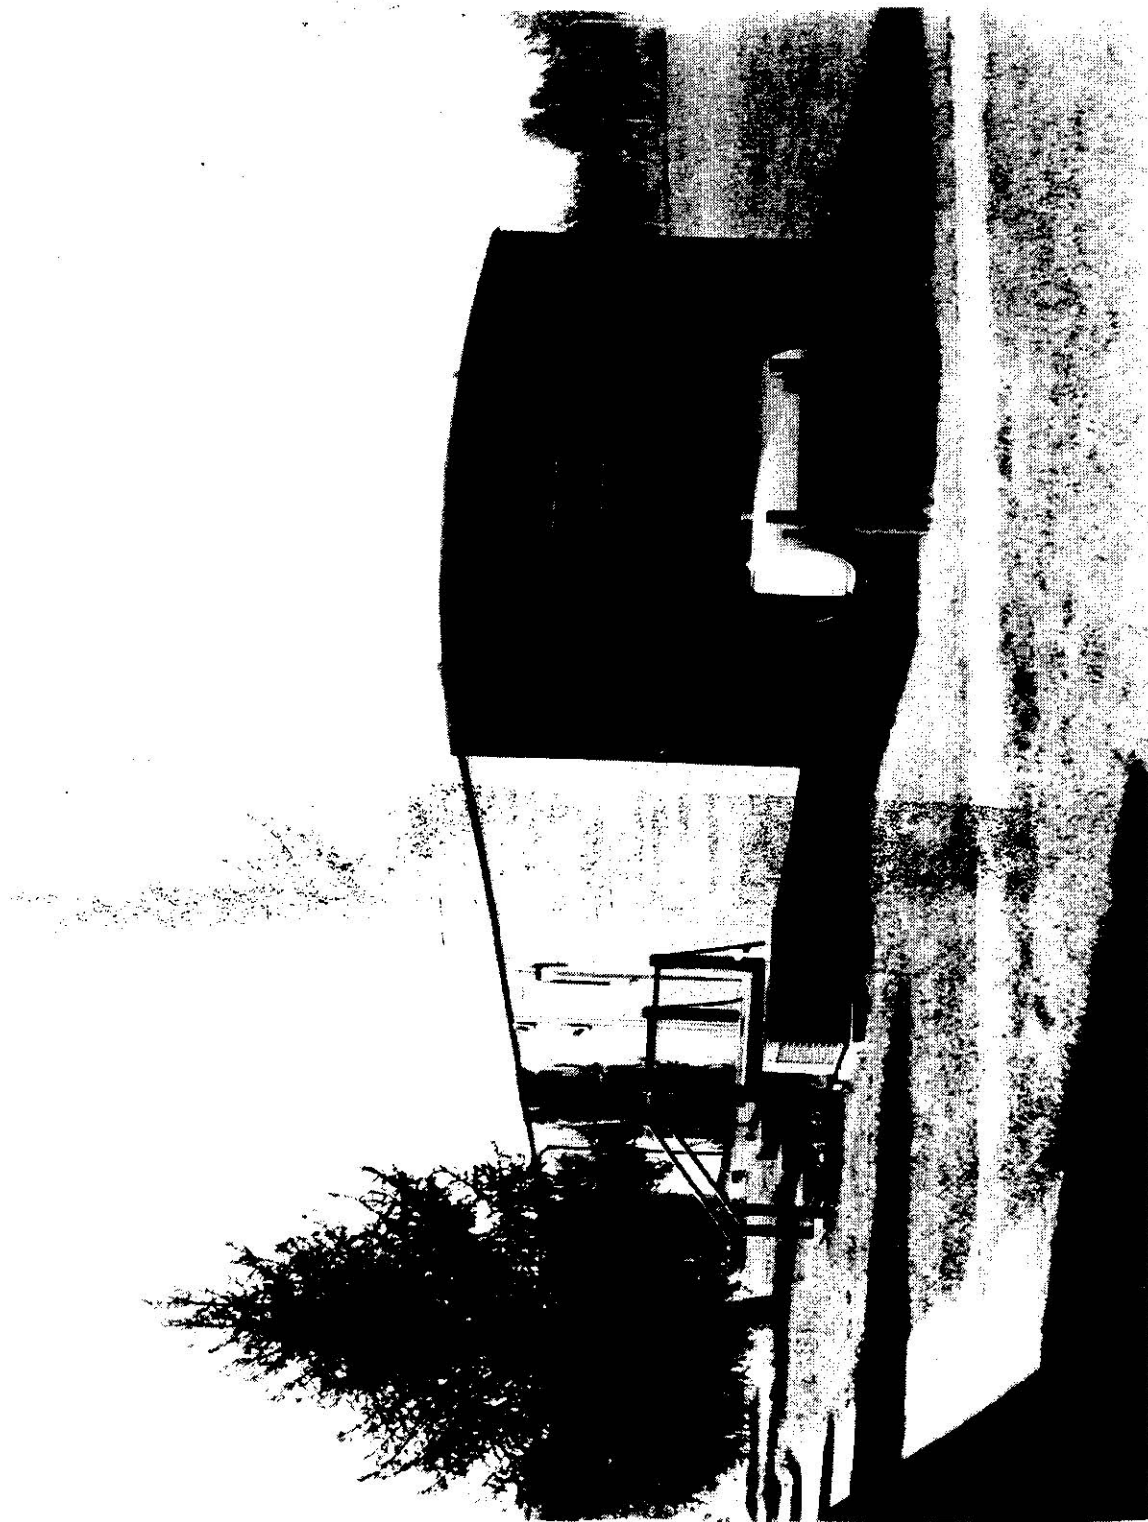
Figure 3. Mobile home showing southern exposure of corridor and bedroom end

The mobile home was installed on the grounds at the NBS Annex facilities and oriented such that the long exterior wall of the corridor leading to the bedrooms was facing south. Since this exterior wall was painted a dark green color, the southern exposure resulted in maximum heating from the sun during the summer test conditions. This was done to provide the maximum possible temperature difference between the interior wall surface of the outside walls and ceiling and the interior air temperature.

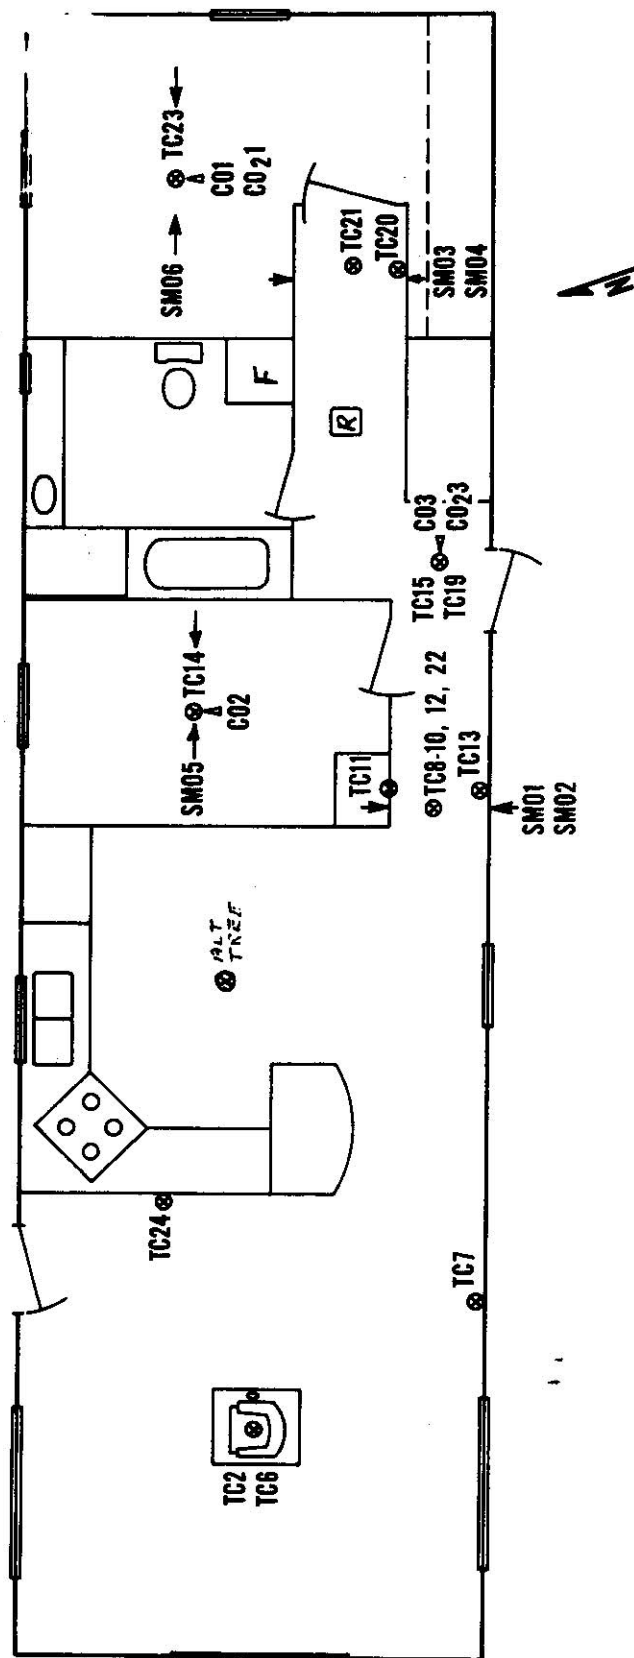
Figure 4. Mobile home floor plan and instrumentation locations

The air return for the air conditioning system was separate from that used by the furnace. This air return was installed in the floor of the corridor almost directly in front of the furnace (figure 4, labeled R). As a result, the return air location was essentially the same for both the summer and winter test conditions.

For the kitchen fires (tests 23, 24 and 25) the thermocouple tree (TC2-TC6) was moved from the center of the living room to the kitchen (see figure 4, labeled alt. tree 2). All other instrument locations remained the same. The overhead kitchen cabinets were removed and replaced with cabinets fabricated from 1.6 cm (5/8 in) calcium silicate board. The range hood was reinstalled above the cooking range and the wall and ceiling surfaces near the stove were also protected with calcium silicate board.

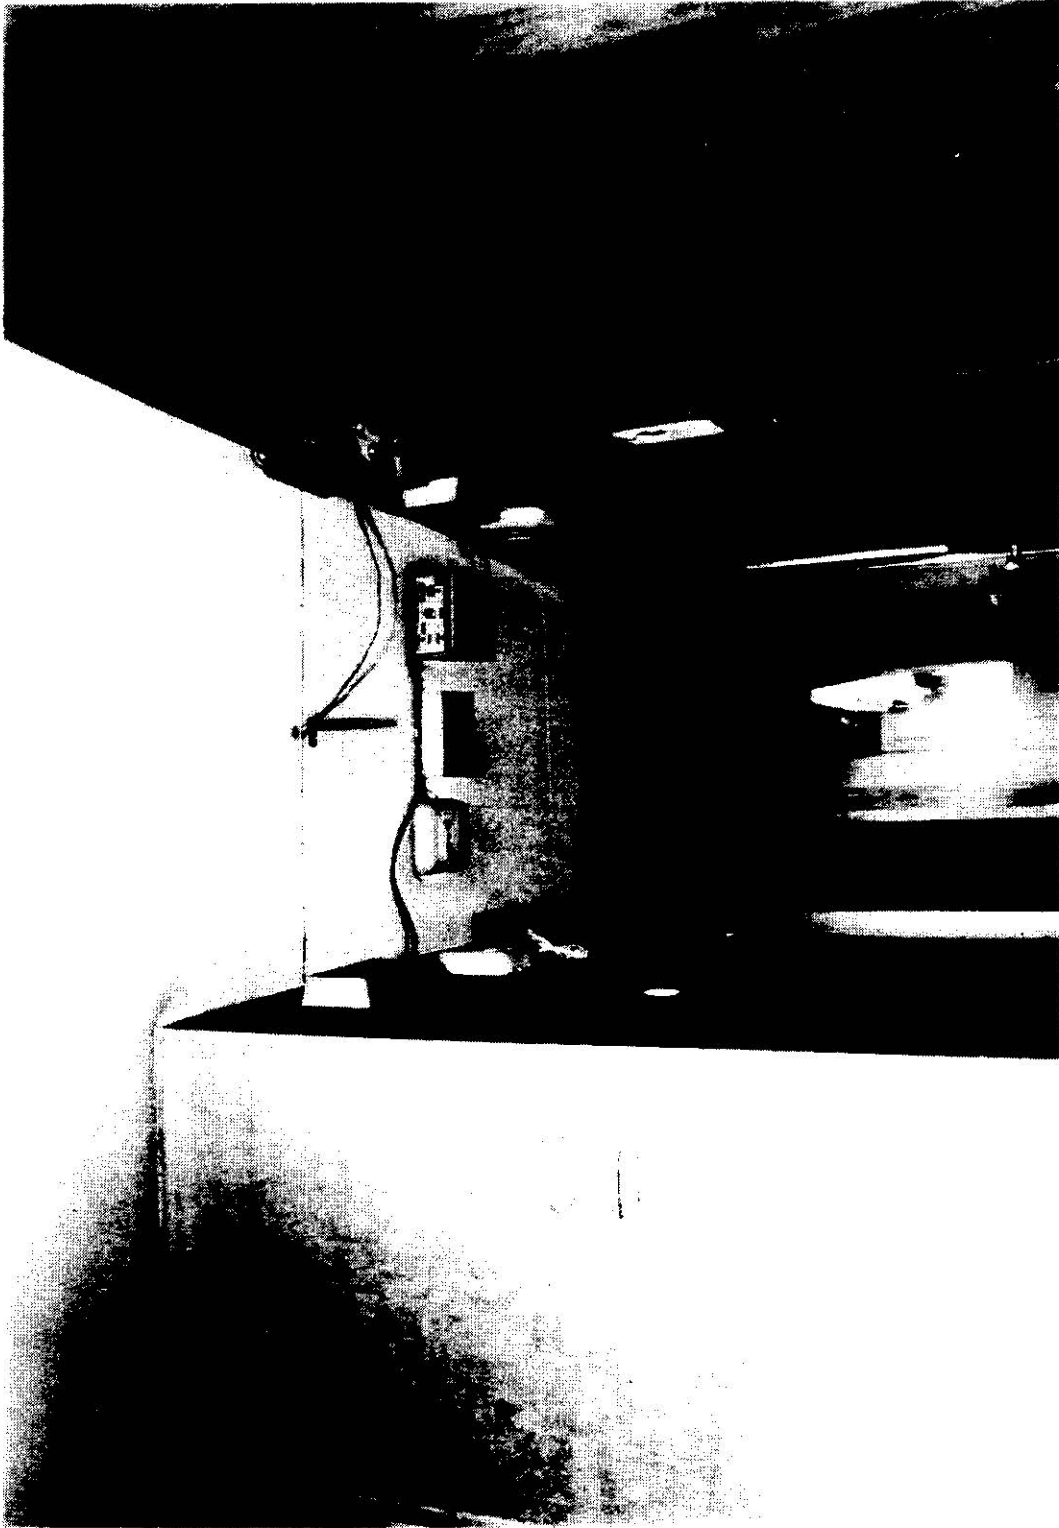
Figure 5. Test detectors and boundary layer probe at front end of corridor

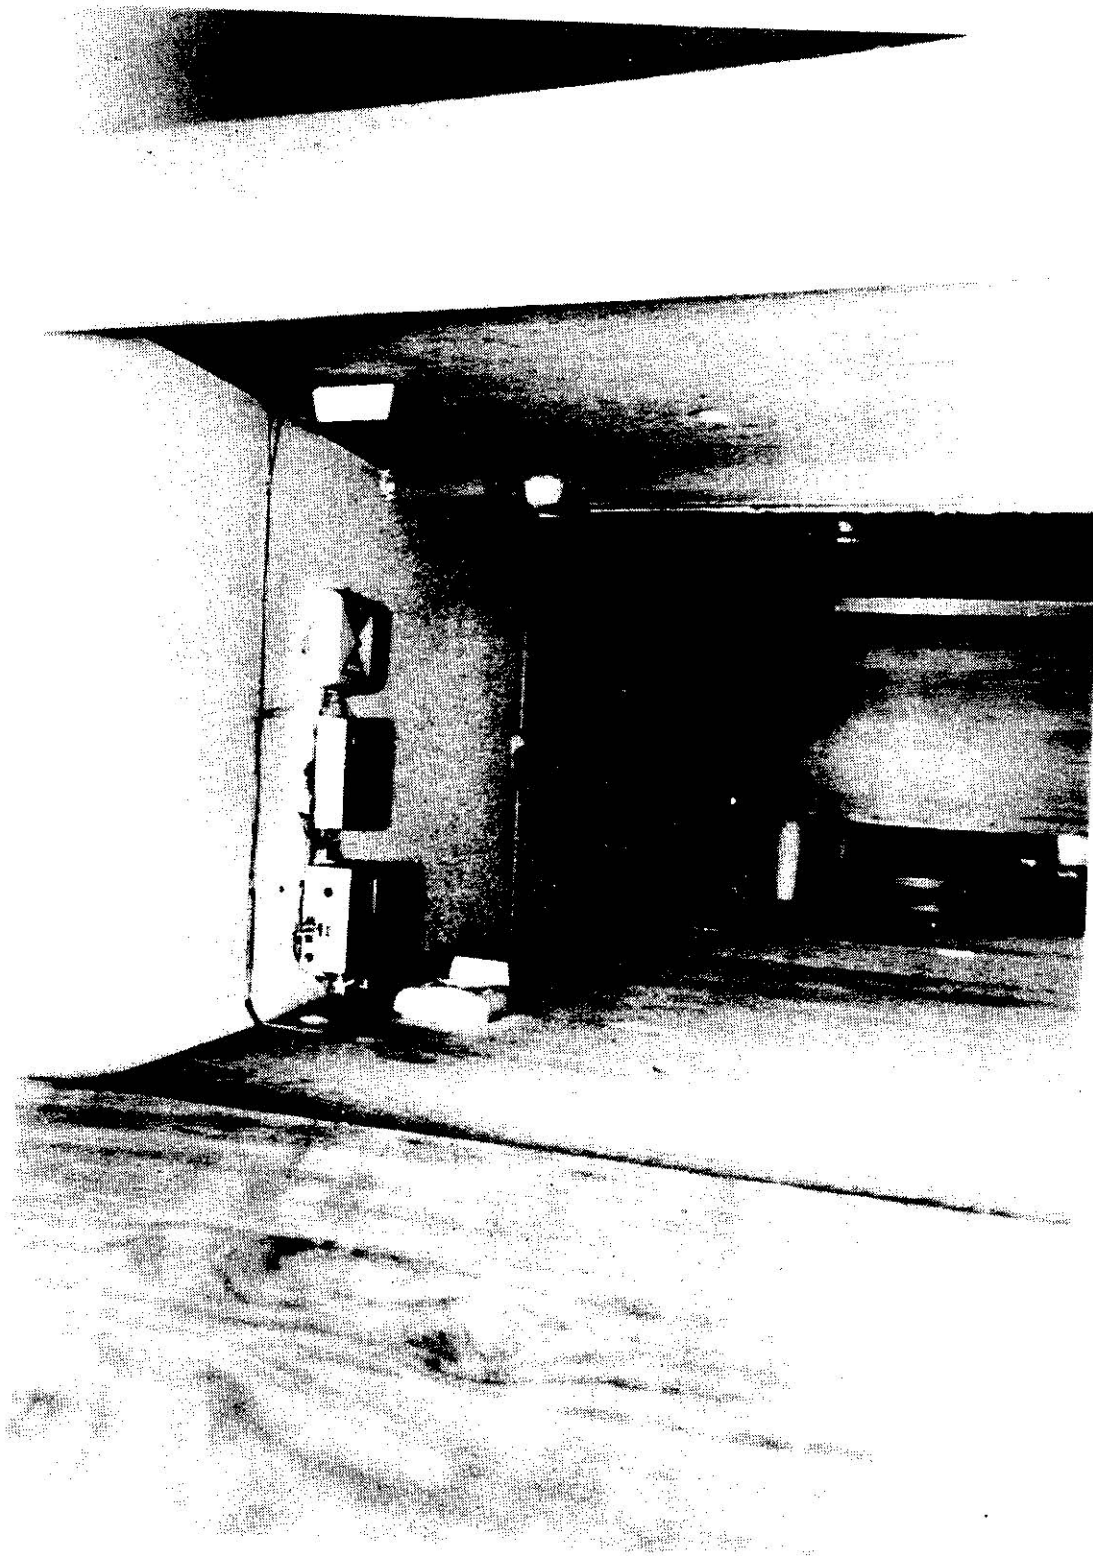
Figure 6. Test detectors mounted in hallway extension at rear of corridor

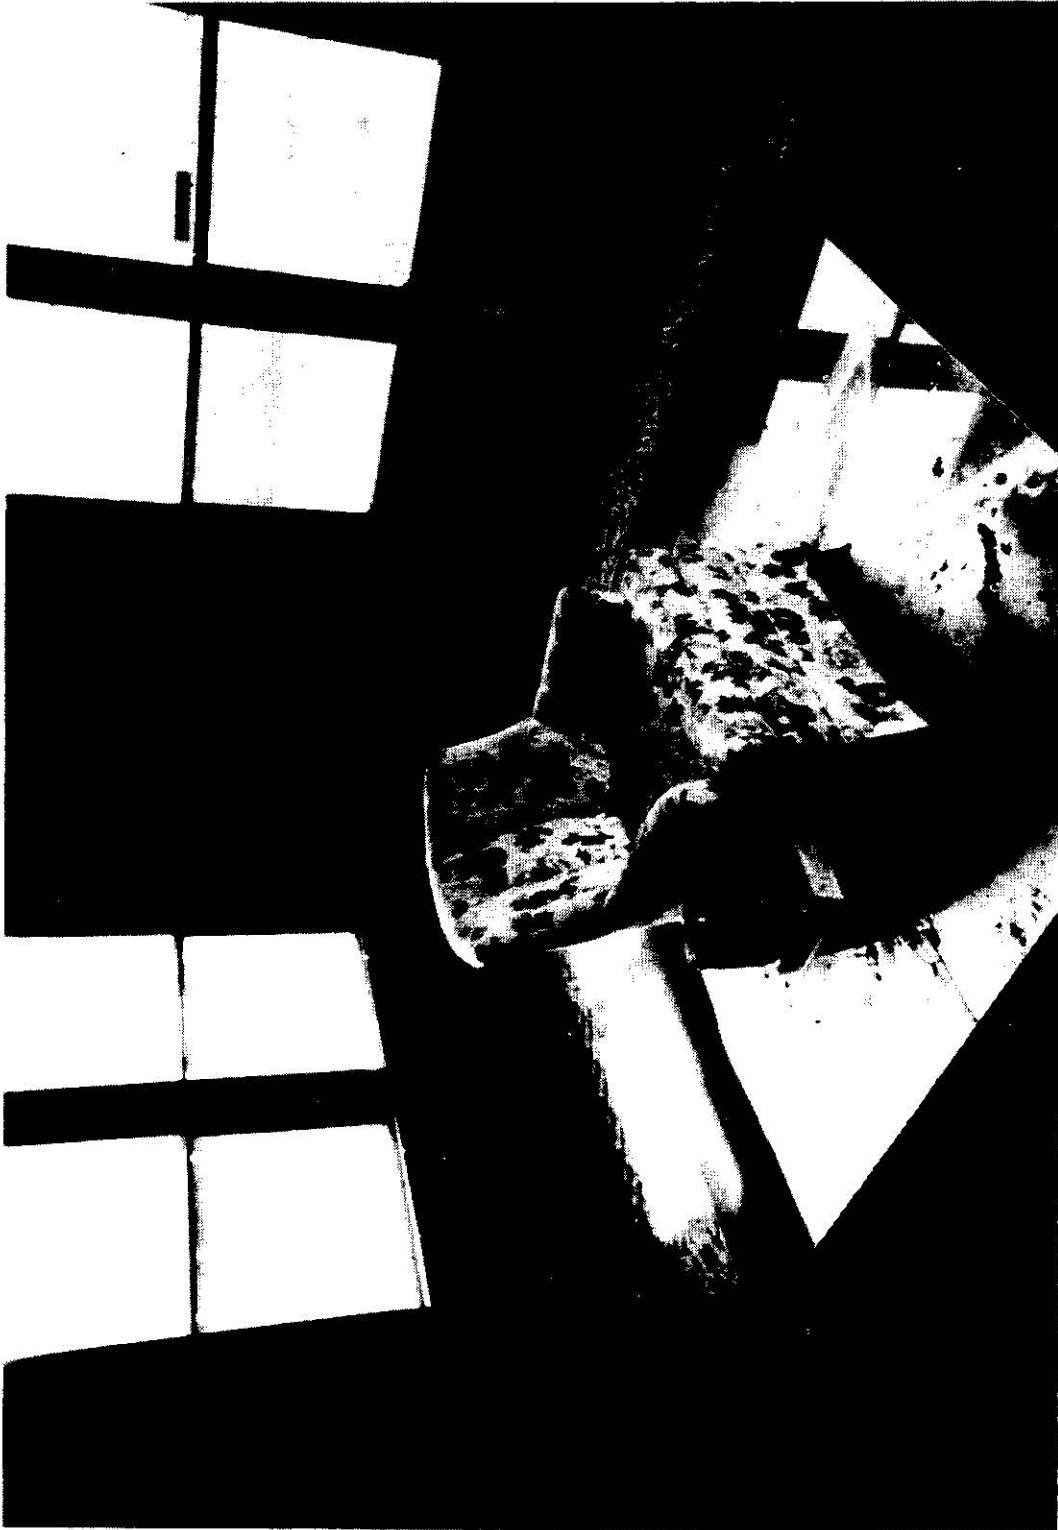
Figure 7. Upholstered chair and wastebasket in test position in living room

The upholstered chair was placed in the center of the living room in a large galvanized metal pan to capture the water used in extinguishment, (see figure 7). This prevented wetting the carpets and increasing the interior humidity for subsequent tests. The metal pan was placed on a sheet of 1.6 cm (5/8 in) calcium silicate board to inhibit melting of the living room carpet. In addition, a 1.2 by 1.8 m (4 by 6 ft) sheet of 1.6 cm (5/8 in) calcium silicate board was secured to the ceiling directly above the chair to prevent direct flame impingement on the gypsum board ceiling. A single thermocouple was placed between the calcium silicate board and the ceiling board to allow monitoring of the interface temperature. This was a precautionary measure to preclude possible ignition of the ceiling joists.

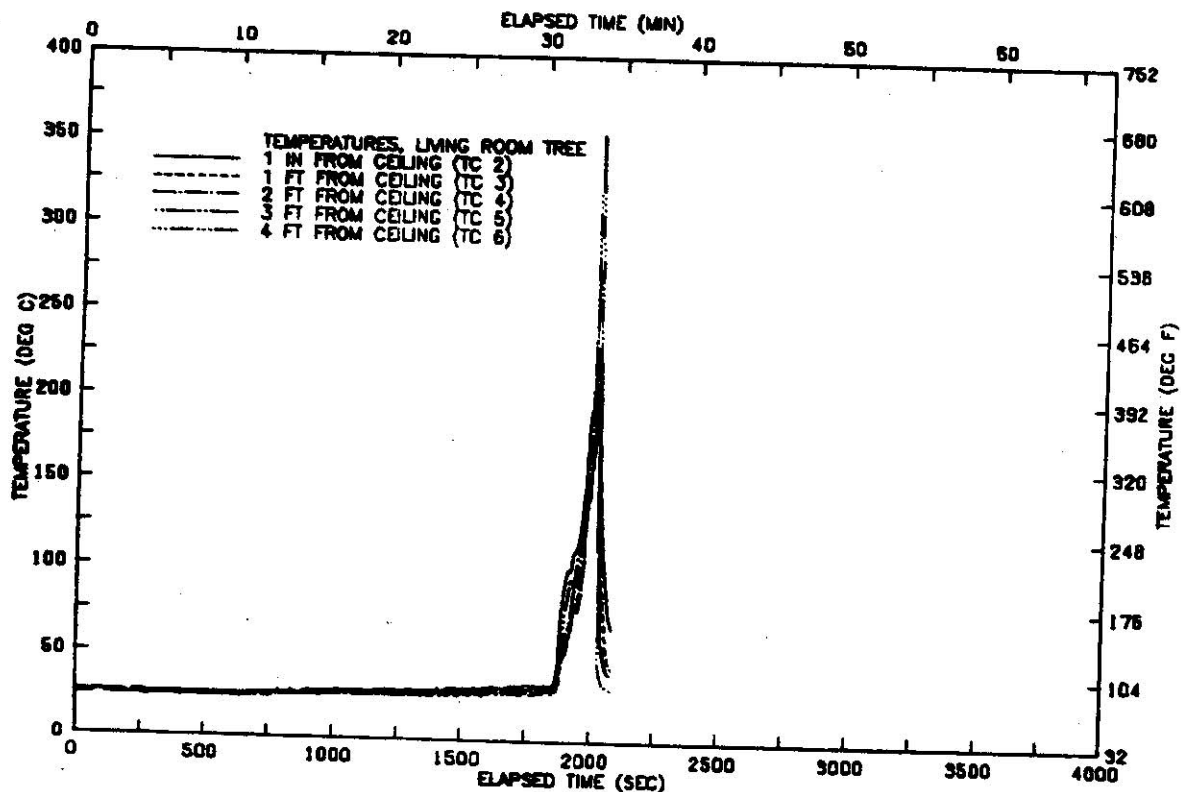
FIGURE A1 VERTICAL TEMP PROFILE
ABOVE CHAIR-TEST 01

As would be expected, the smoldering tests resulted in a very gradual, almost linear increase in ambient temperature until transition to flaming (e.g. see figures A1, A11). Once transition occurred, temperatures throughout the mobile home increased quite rapidly; the duration of the tests being limited by the attainment of high temperatures (est. 60°C) at the living room windows. The peak temperatures observed at test termination in both the smoldering and flaming tests were of the same order of magnitude. However, as would be anticipated, the elapsed time was quite different for the two general types of fires, with the smoldering tests taking 2-3 times longer to reach termination temperatures.

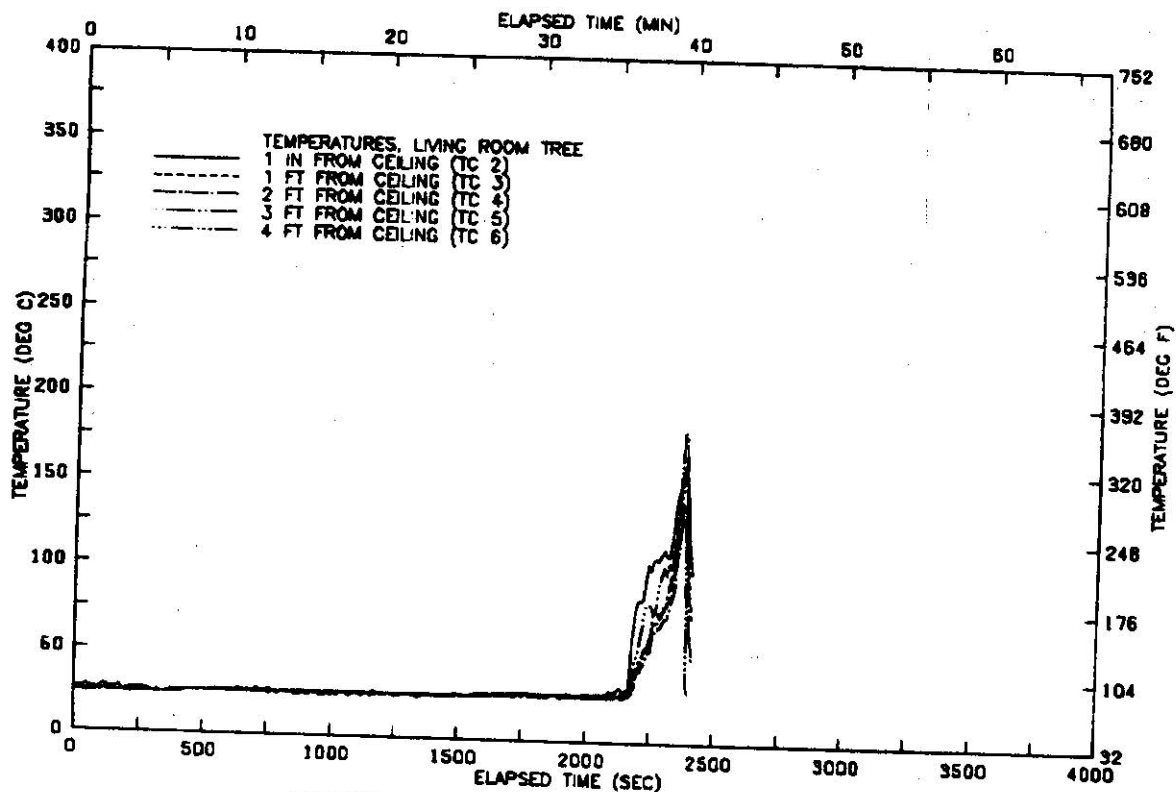
FIGURE A11 VERTICAL TEMP. PROFILE
ABOVE CHAIR-TEST 02

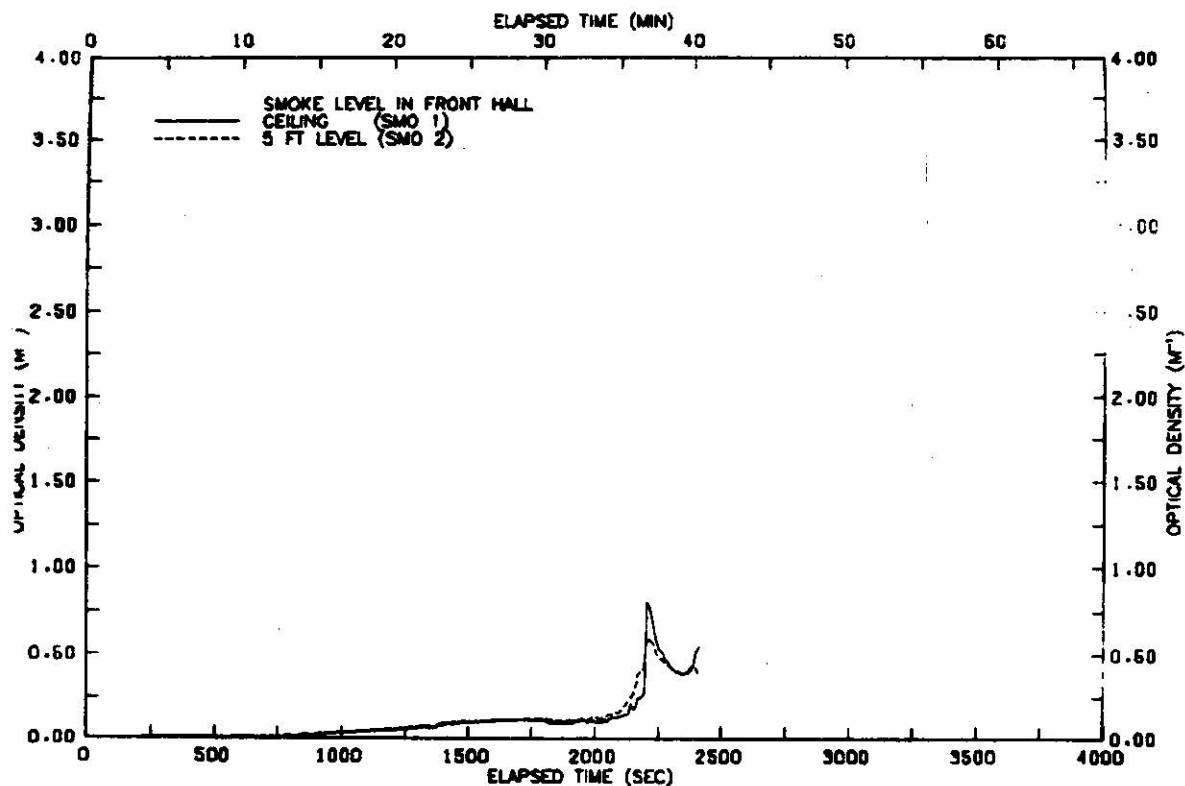
FIGURE A17 SMOKE LEVELS IN FRONT HALLWAY-TEST 02

As was mentioned earlier, the rate of smoke generation from the smoldering chairs varied considerably. In test 2, smoke levels in the corridor and bedrooms were quite low (≤ 0.2 OD/m) at the point of transition to flaming (figures A17, A19). Under this condition some ionization detectors did not respond until a few seconds after transition to flaming due to the lack of sufficient smoke at the detector location to cause alarm of the ionization detectors. In most of the tests, however, there was sufficient smoke to result in alarm of the ionization detectors prior to transition to flaming. Since smoldering materials typically produce fairly few numbers of relatively large size smoke particles, it took between 0.15 to 0.23 OD/m (10 to 15 %/ft) obscuration smoke level, measured by an extinction photometer, to result in alarm.

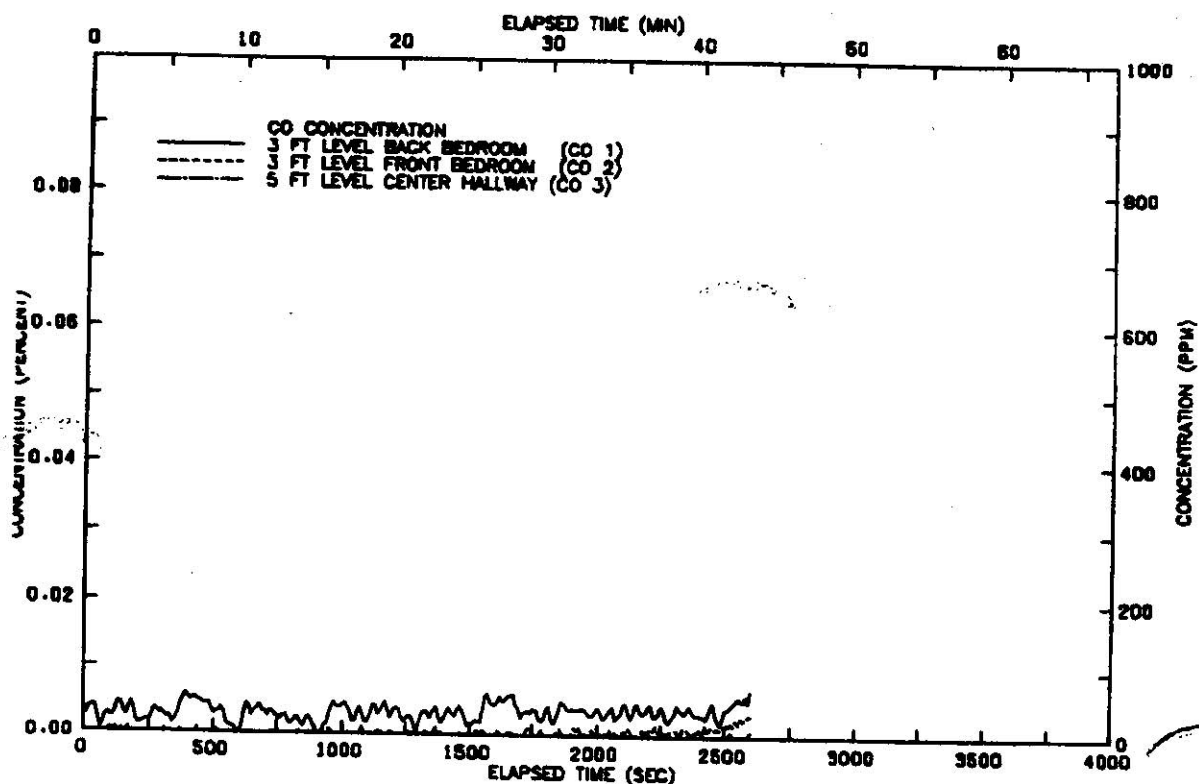
FIGURE B109 CARBON MONOXIDE
CONCENTRATION-TEST 23

Carbon monoxide and carbon dioxide levels for the kitchen grease fires tended to be significantly lower than those for the previous tests with upholstered chairs. This was attributed to the much smaller amount of fuel being burned in the grease fires as compared to the chair fires. There was almost no CO and CO₂ produced prior to auto-ignition of the oil and, while higher rates of gas generation were evident in the burning oil, the time of flaming was very short, resulting in little gas accumulation. This is demonstrated in the plotted data in the very low levels of CO and CO₂ for all three kitchen fires. (Figures B109, B110, B120, B121, B131 and B132.)

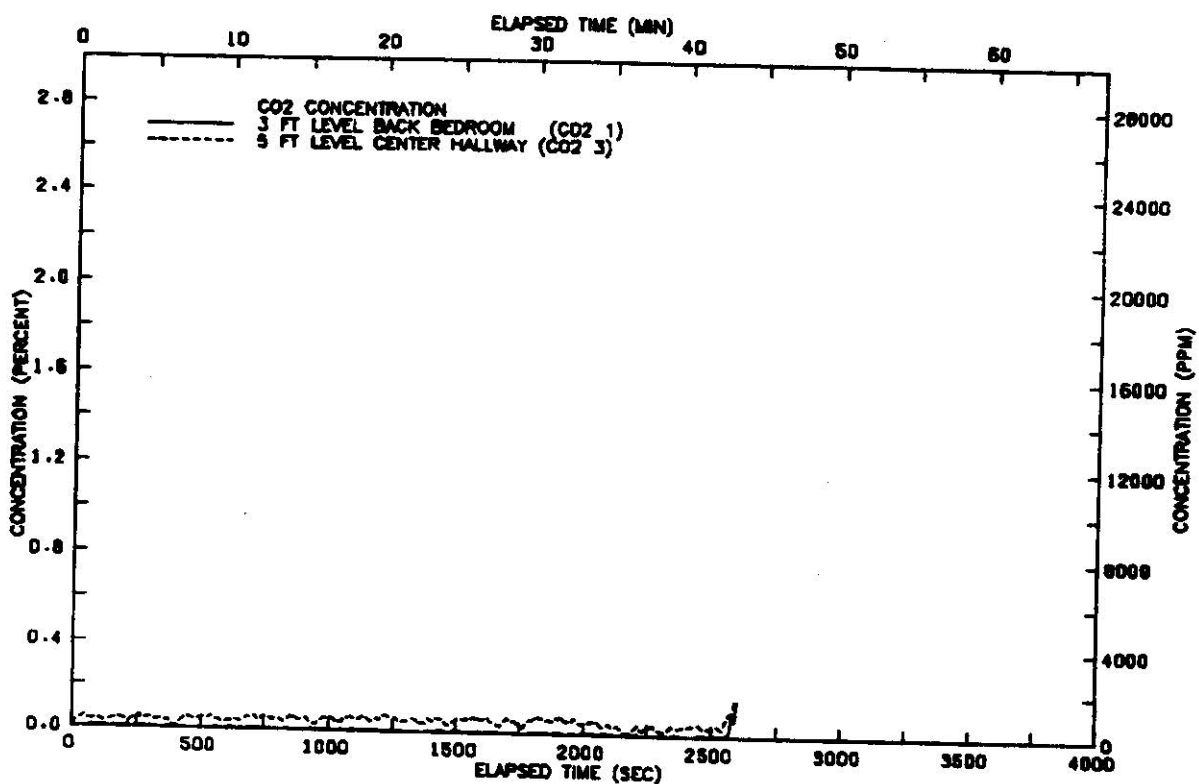
FIGURE B110 CARBON DIOXIDE
CONCENTRATION-TEST 23

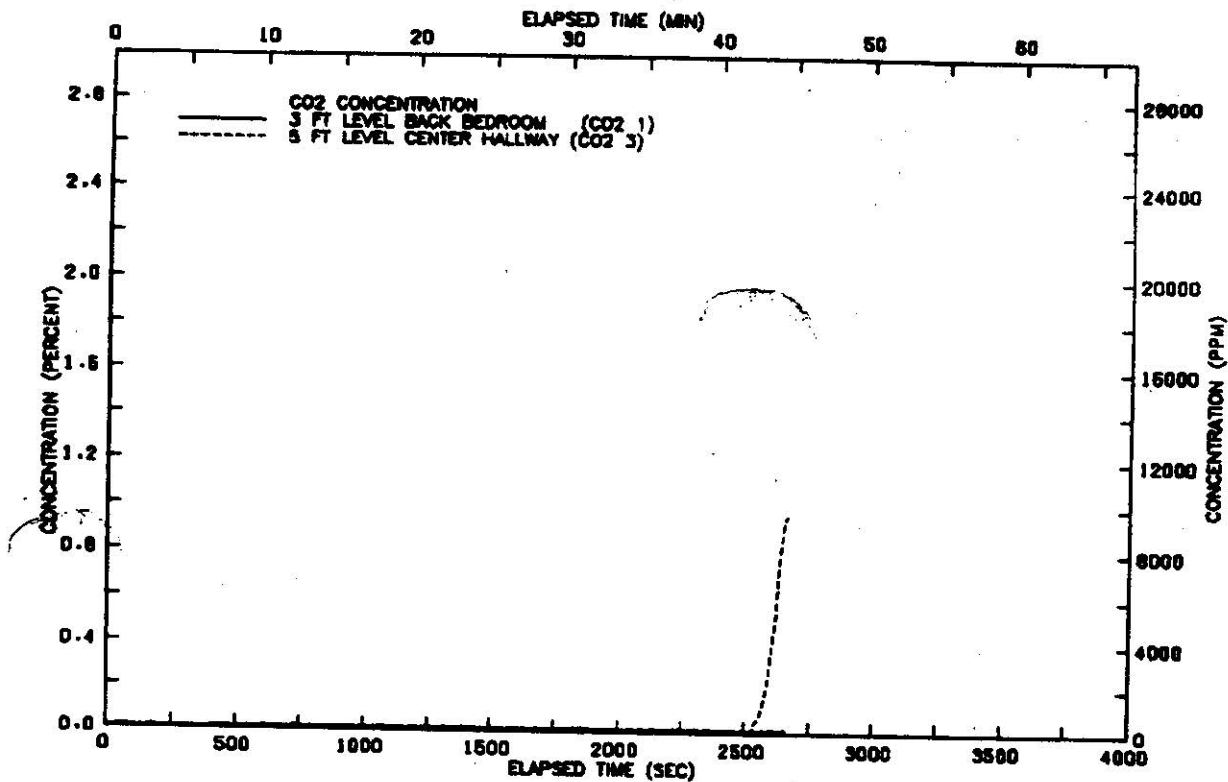
FIGURE B121 CARBON DIOXIDE
CONCENTRATION-TEST 24

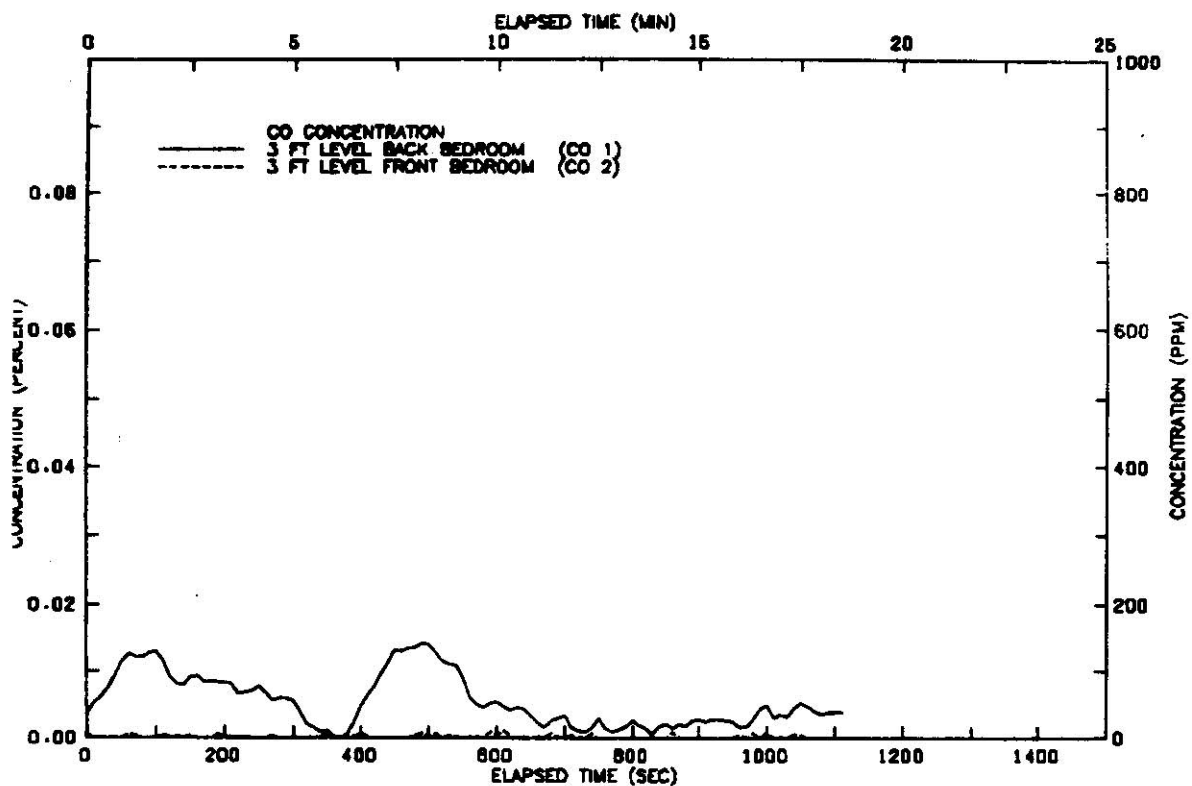
FIGURE B131 CARBON MONOXIDE
CONCENTRATION-TEST 25
